# **The Road Inventory of Deer Flat National Wildlife Refuge Nampa, ID**

Prepared By:  
Federal Highway Administration  
Central Federal Lands Highway Division  
April 2013

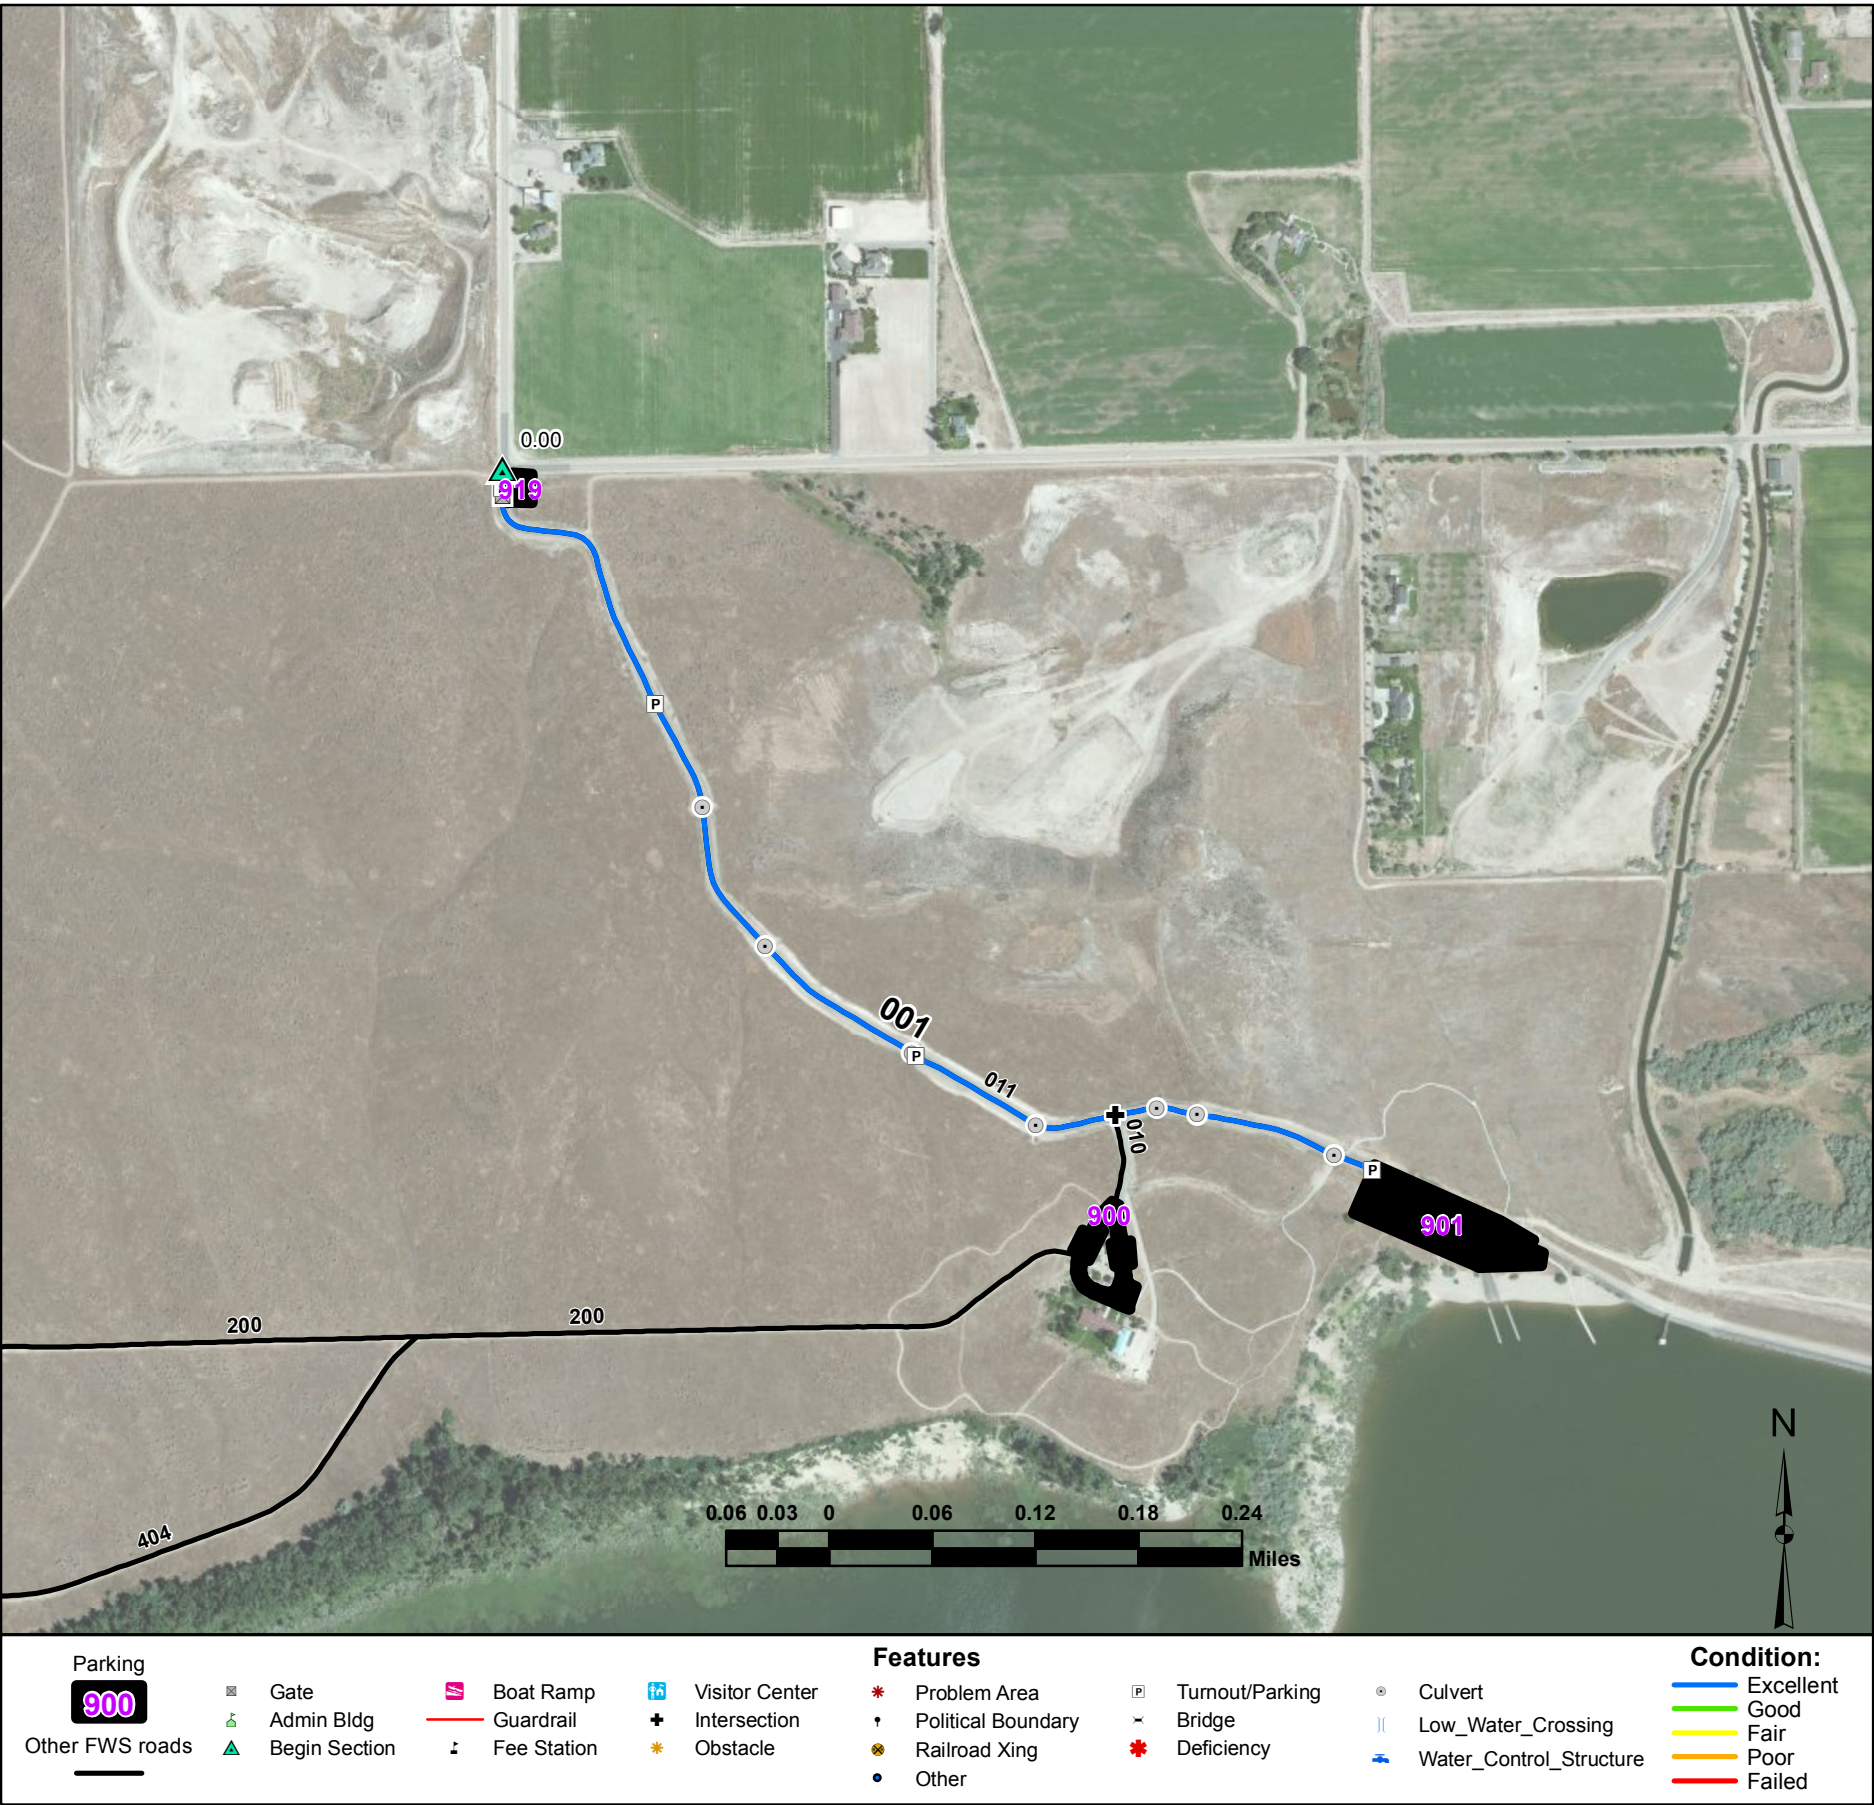
Upper Embankment Road

Asset Number	10061649				
Section Number	001				
Section Length (miles)	0.73				
Inspection Date	03-12-2013				
Surface Type	Asphalt				
Number of Lanes	2				
Roadway Width (feet)	24				
Condition	Excellent				
Remaining Service Life (years)	20				
Estimated Cost to Repair	\$0				
Current Replacement Value	\$890,800

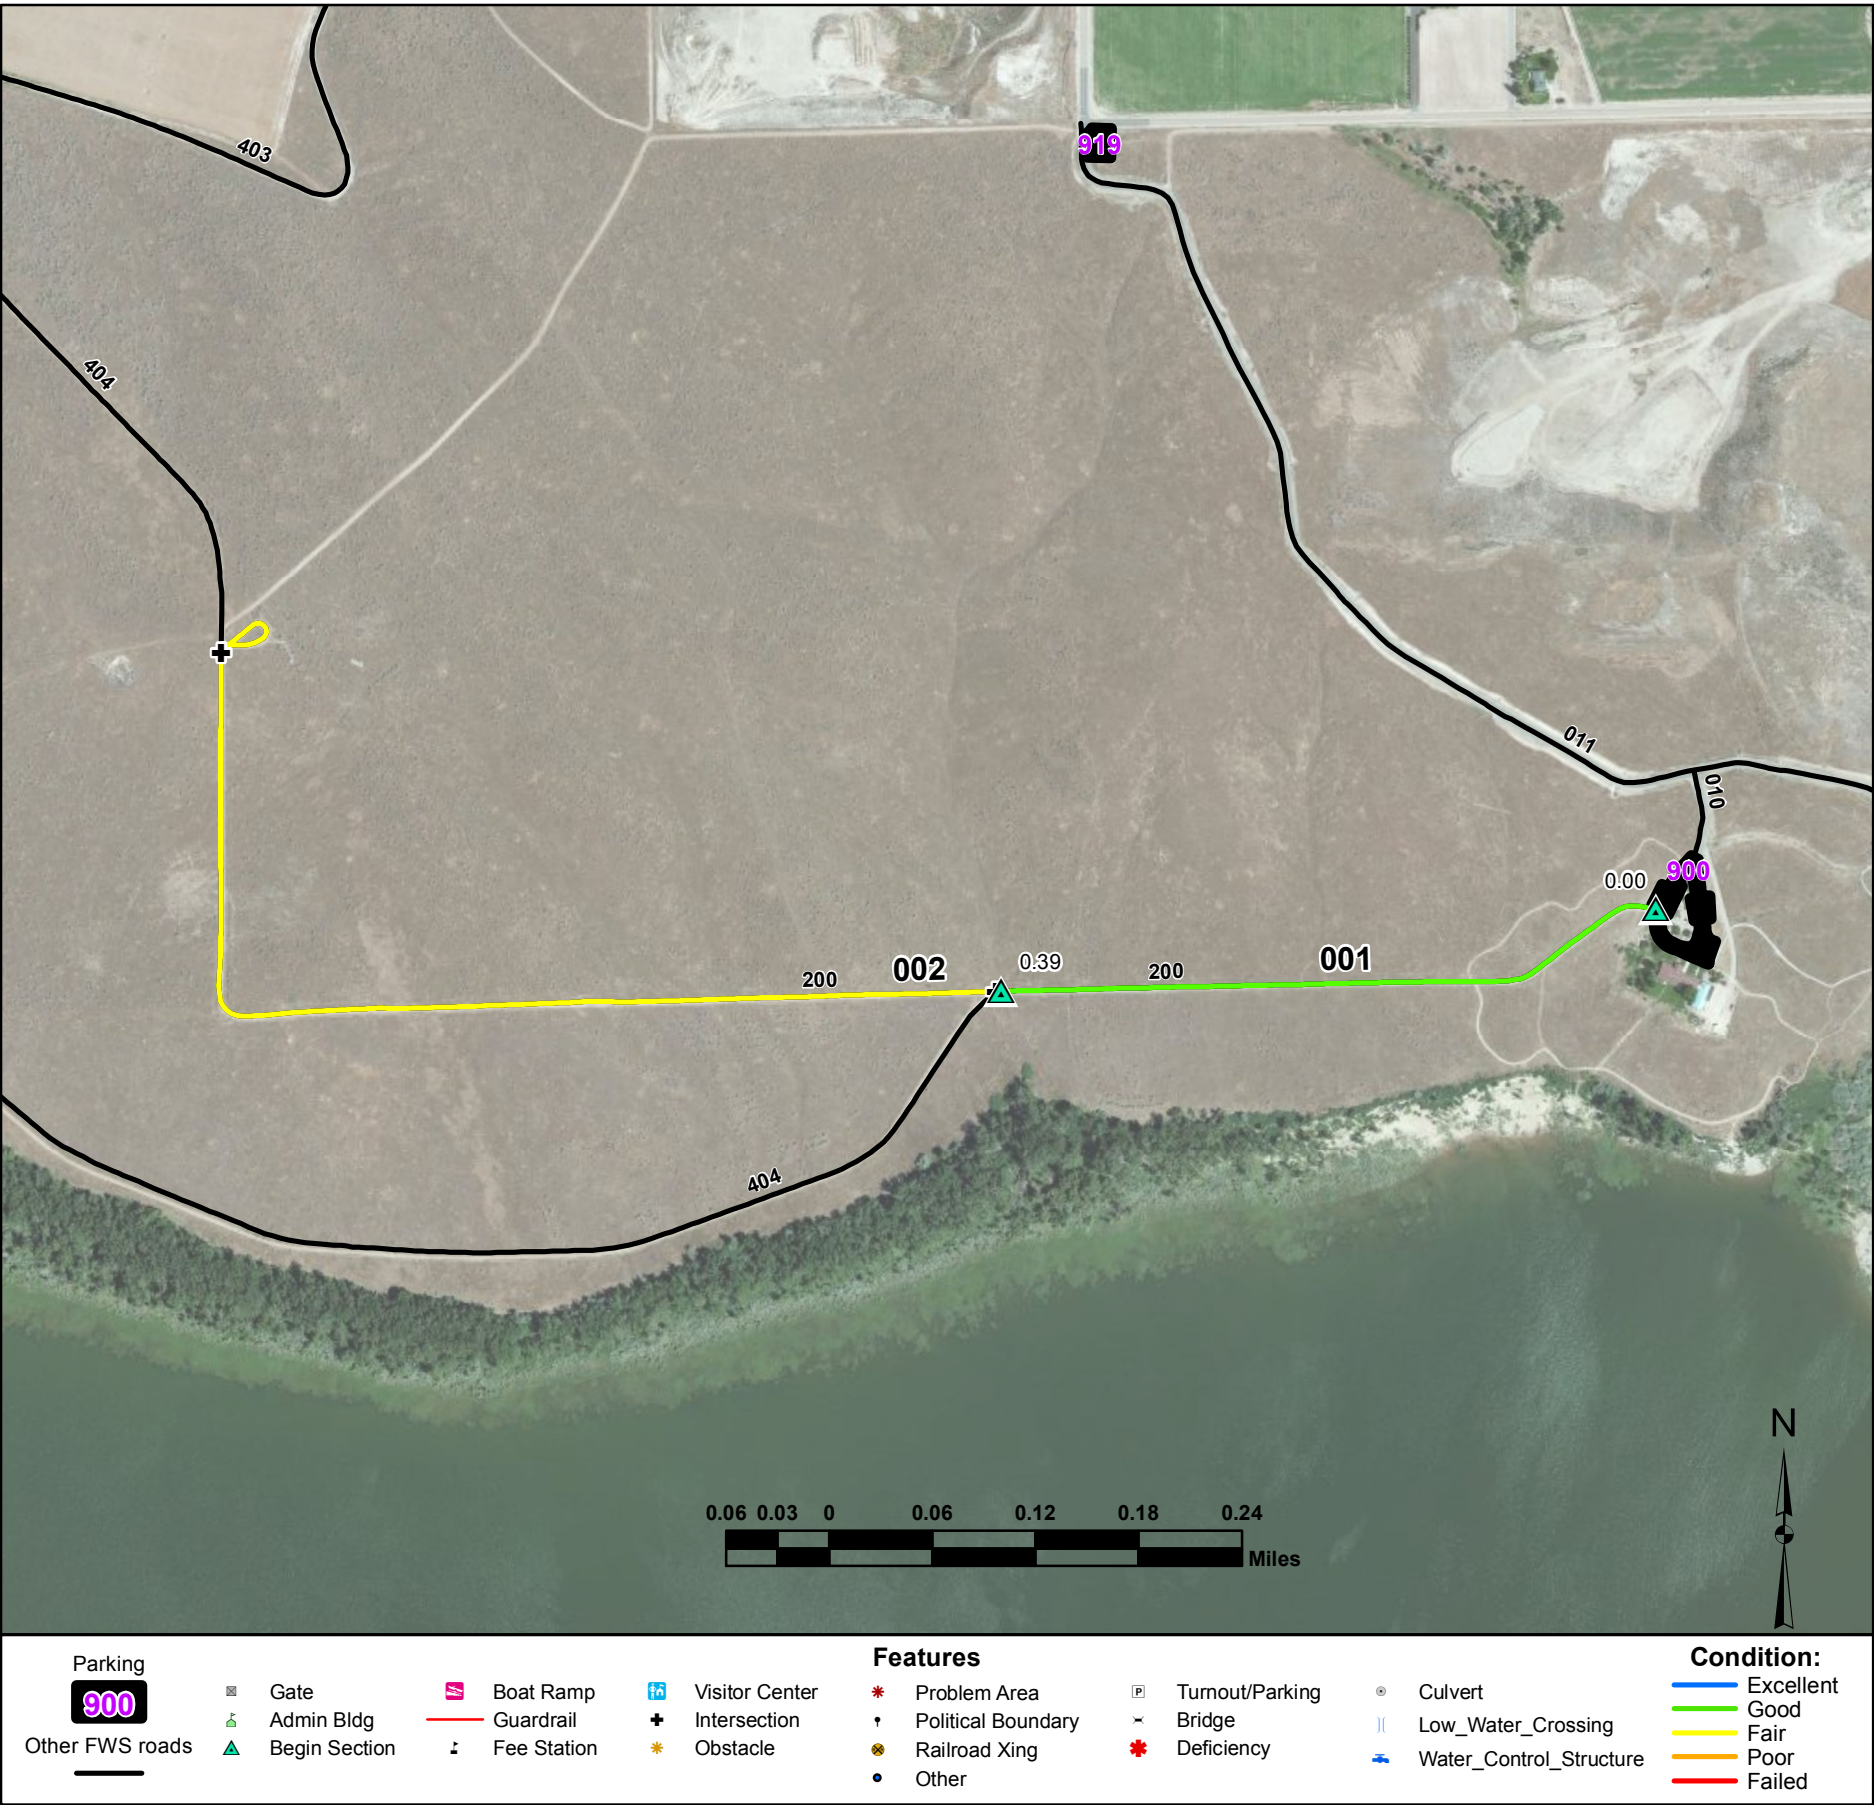
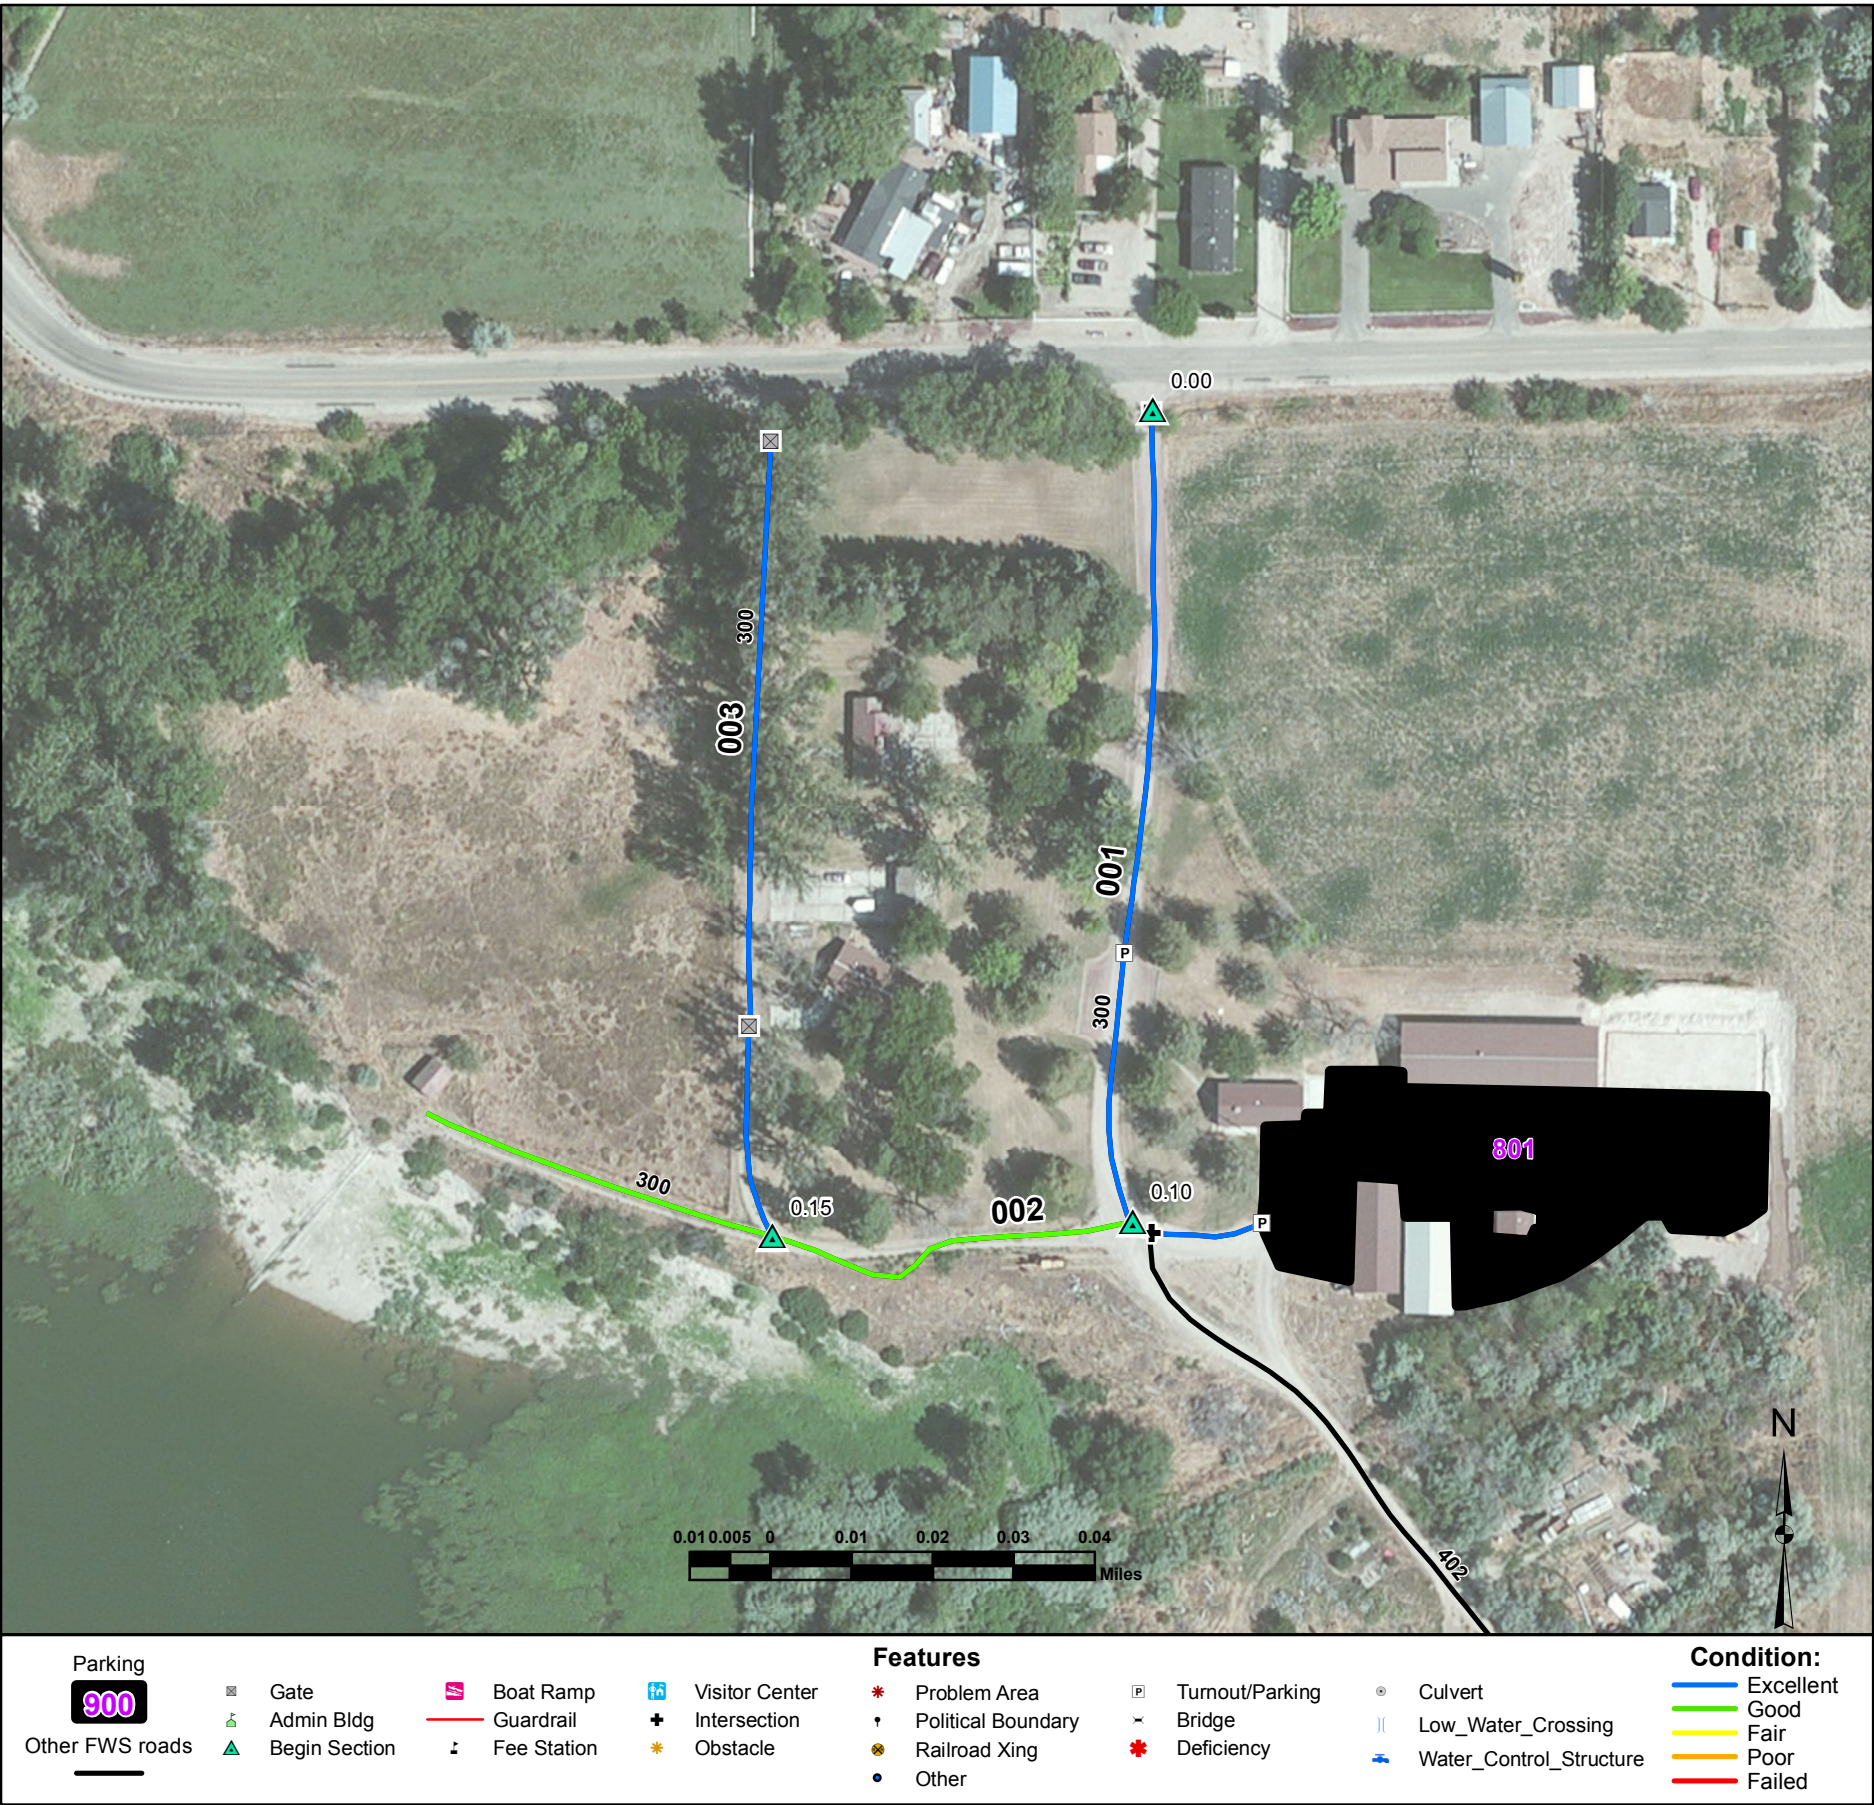
### Lower Dam Youth Camp Access Road

Asset Number	10050908				
Section Number	001				
Section Length (miles)	0.28				
Inspection Date	03-12-2013				
Surface Type	Gravel				
Number of Lanes	2				
Roadway Width (feet)	42				
Condition	Good				
Remaining Service Life (years)	7				
Estimated Cost to Repair	\$500				
Current Replacement Value	\$197,000

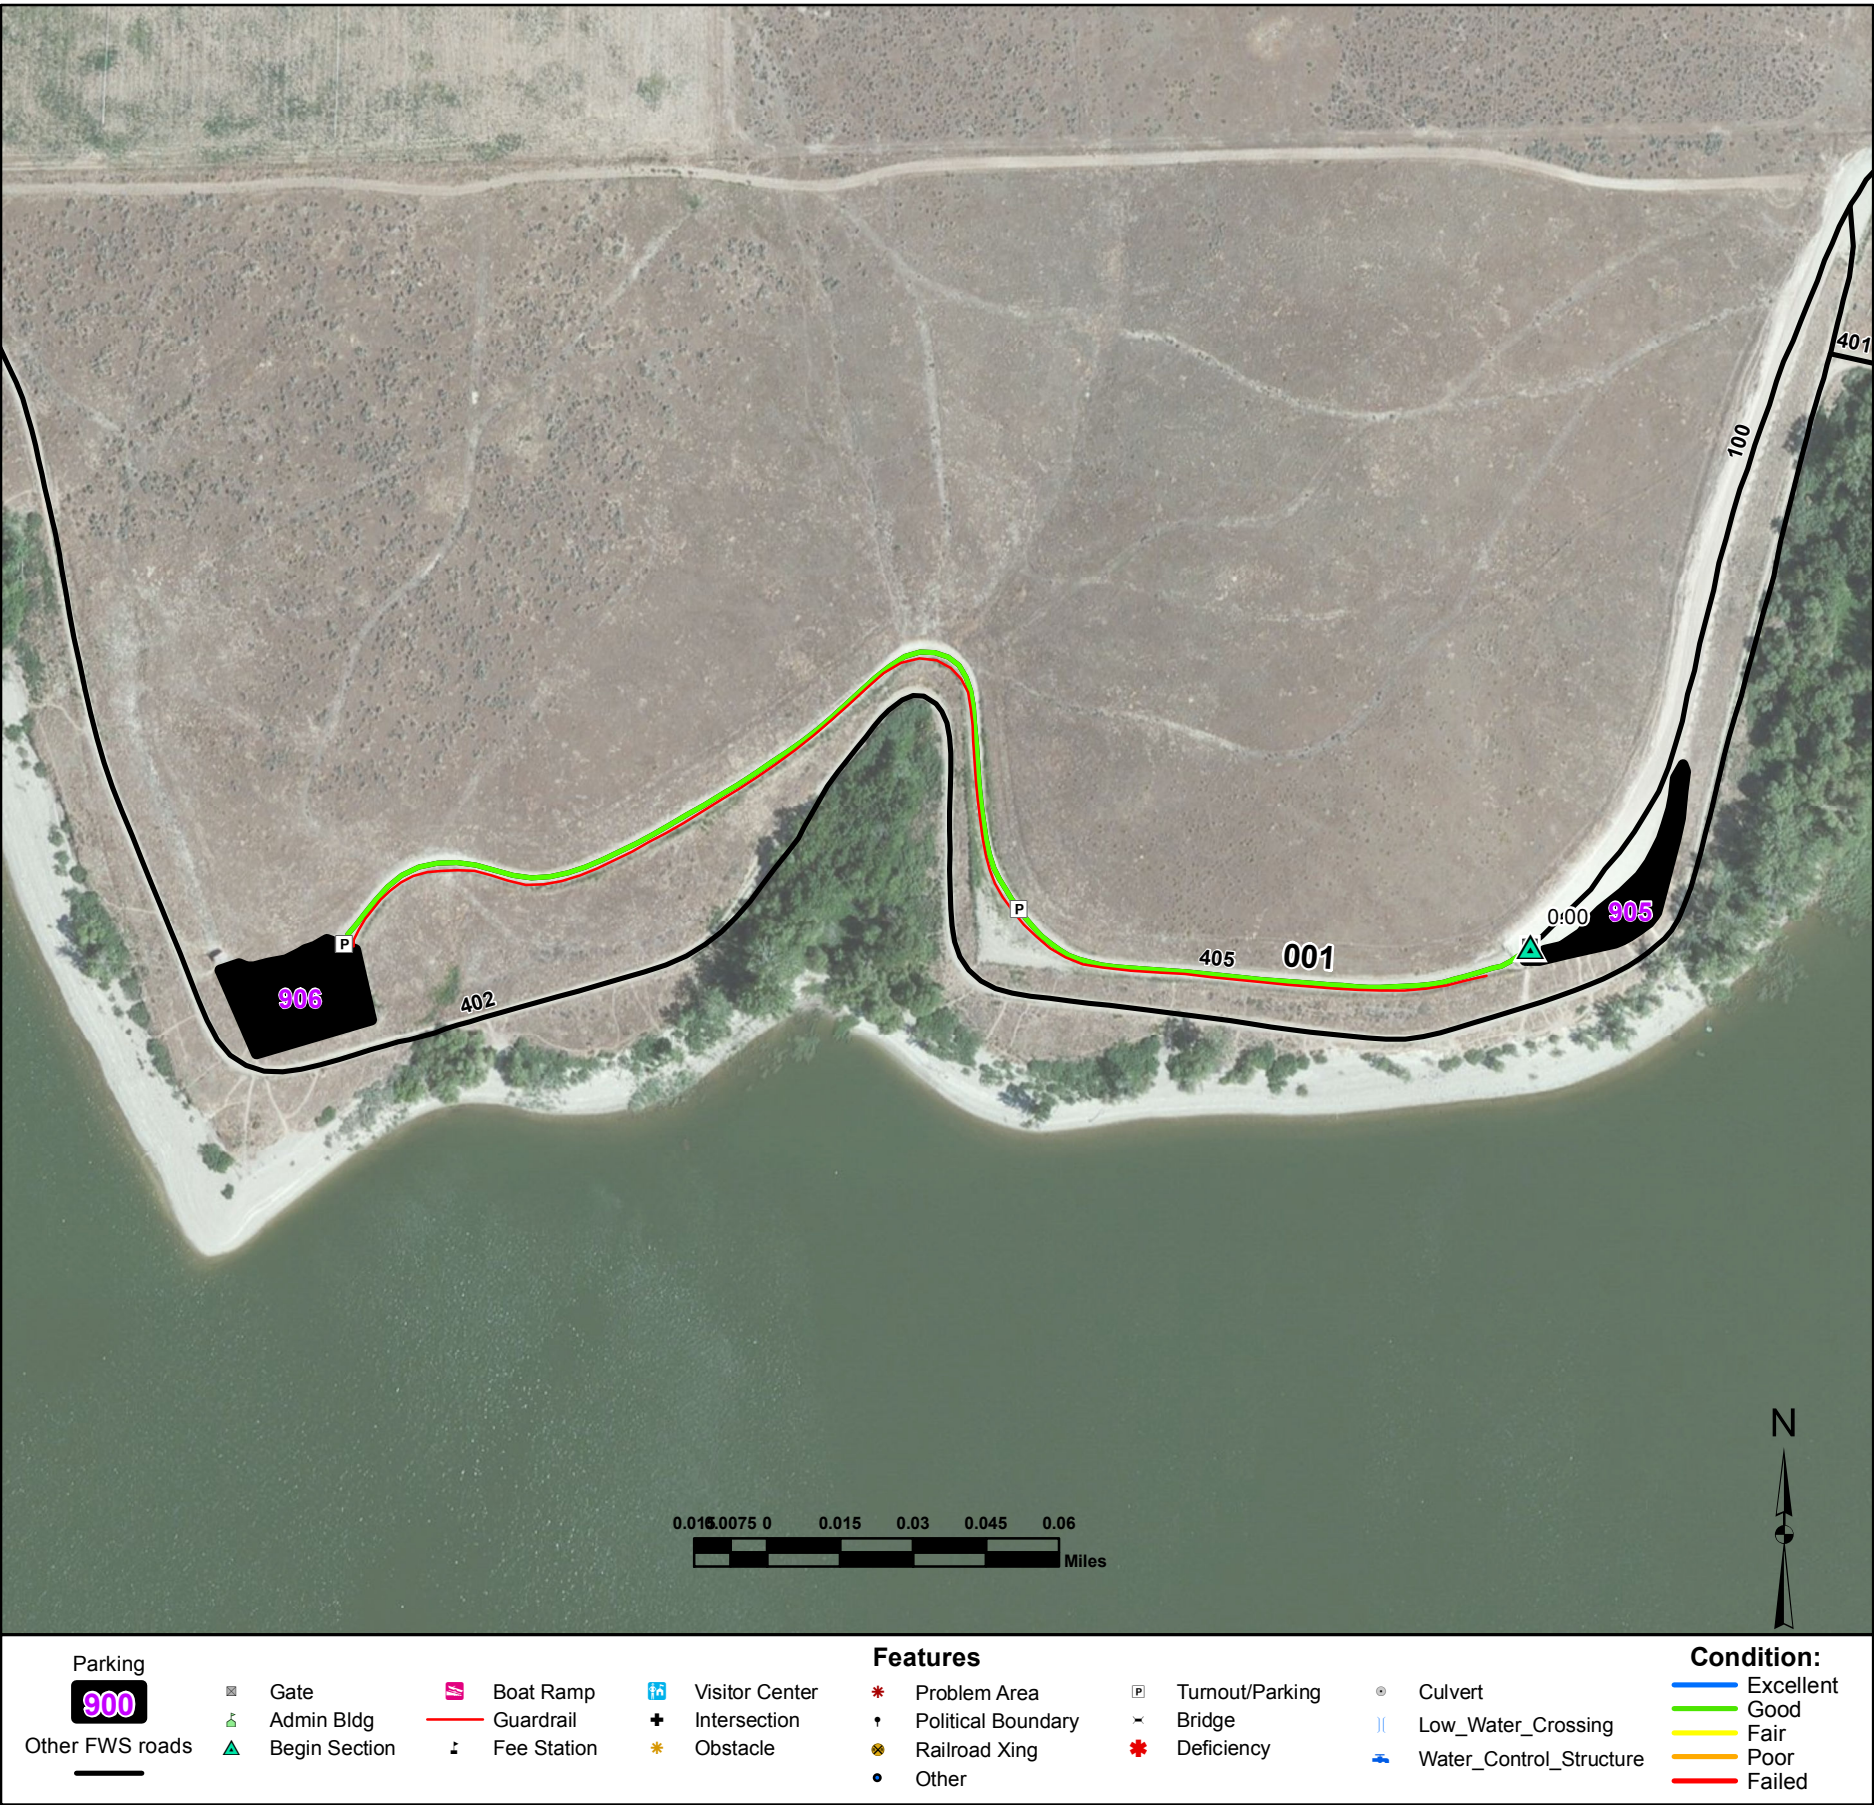
Field 5 Access Road

Asset Number	10005316	10005316	10005316	10005316	
Section Number	001	002	003	004	
Section Length (miles)	0.97	0.17	0.97	0.88	
Inspection Date	03-12-2013	03-12-2013	03-12-2013	03-12-2013	
Surface Type	Gravel	Gravel	Native	Native	
Number of Lanes	1	1	1	1	
Roadway Width (feet)	12	14	12	12	
Condition	Good	Good	Good	Good	
Remaining Service Life (years)	7	7	5	5	
Estimated Cost to Repair	\$1,600	\$300	\$1,700	\$1,500	
Current Replacement Value	\$682,300	\$119,600	\$353,000	\$320,200

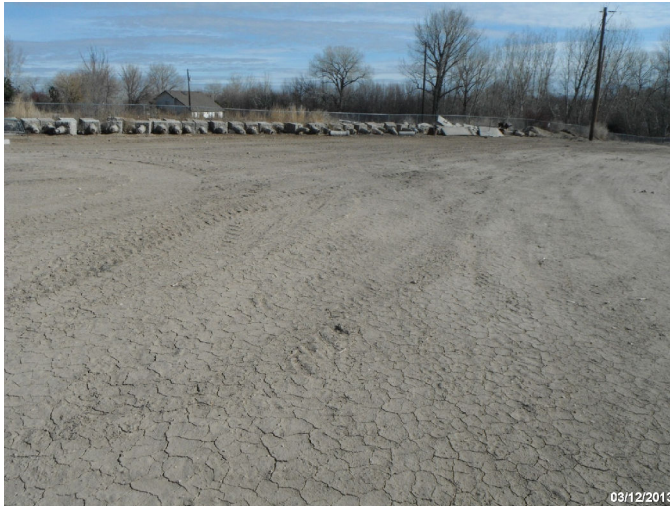
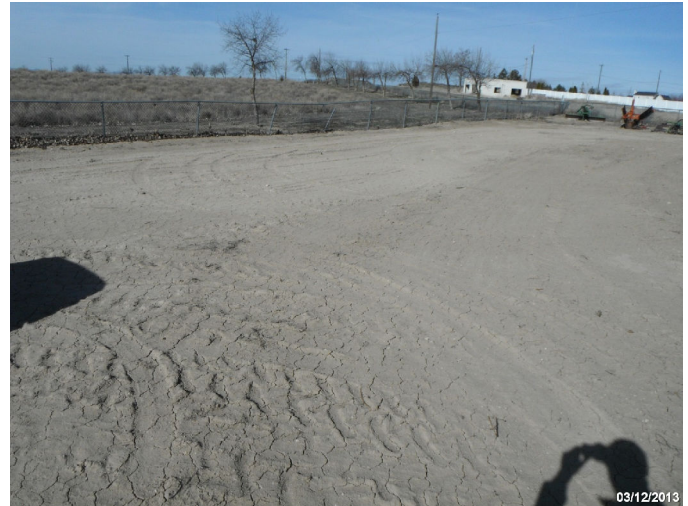
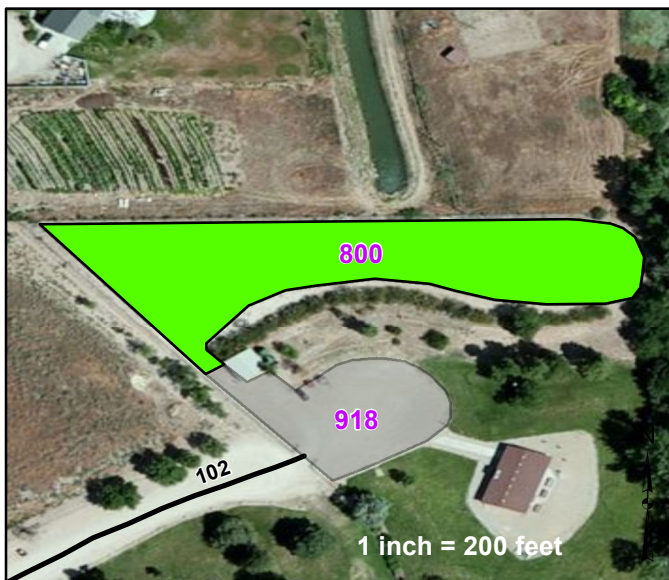
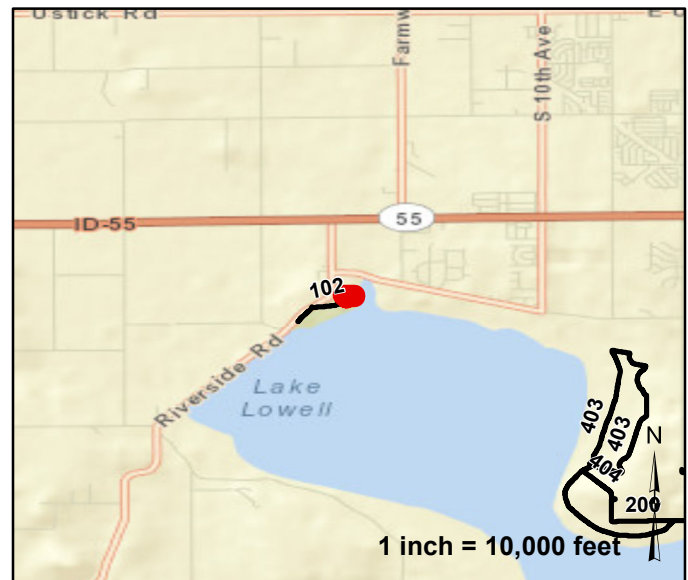
**Route Number: 800**  
**Environmental Education Rear Parking**  
 From Environmental Education Parking (Route 918)

Asset Number	Area (Sq Ft)	Spaces	Condition	Surface Type	Cost to Improve	Inspection Date	Current Replacement Value
-	35557	25	Good	Native	\$5,400	03-12-2013	\$77,400

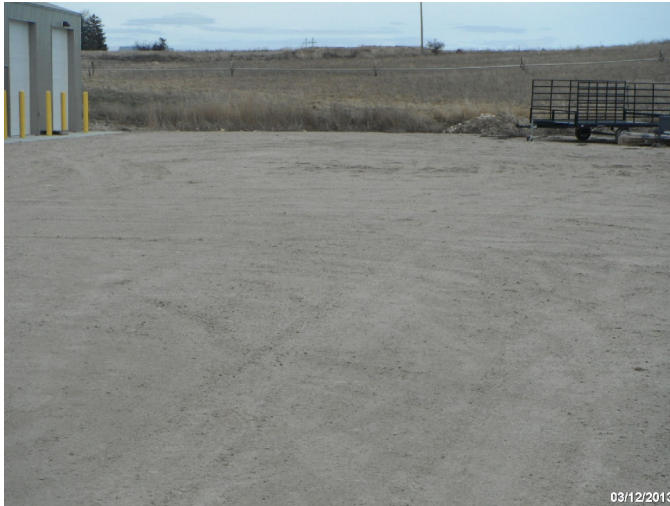
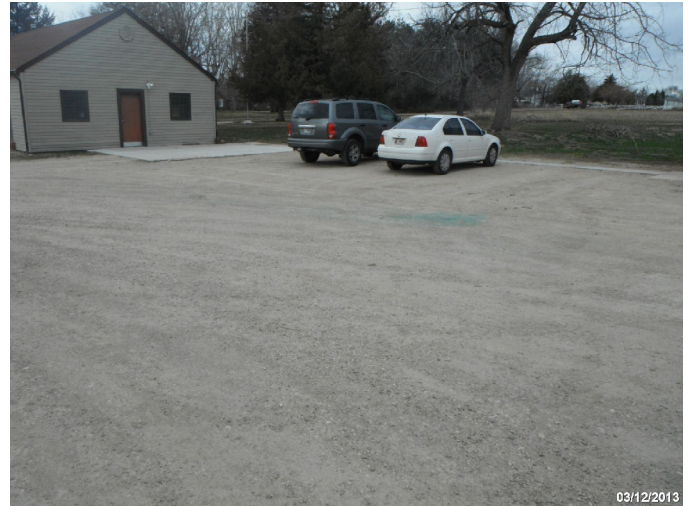
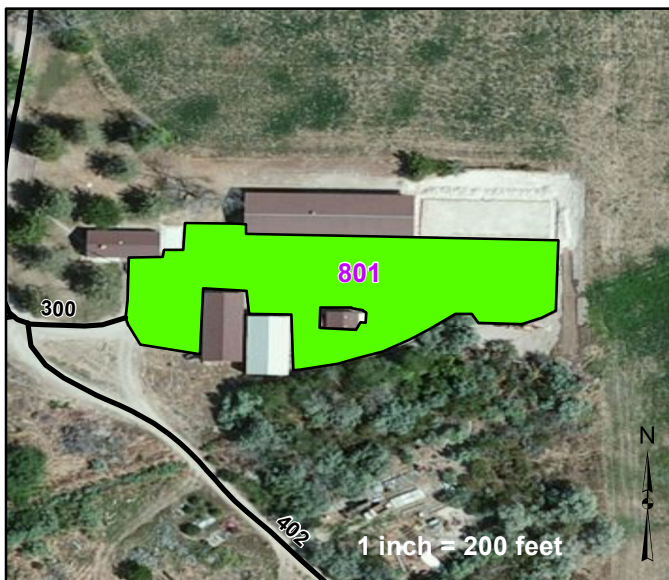
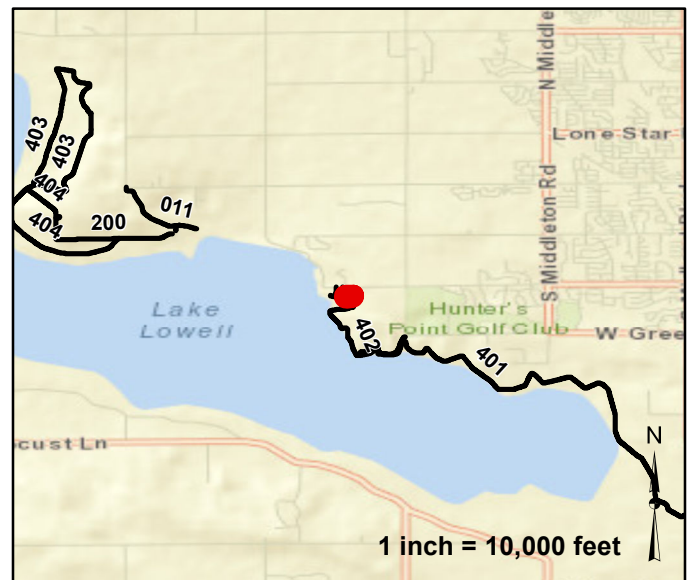
# Route Number: 801

Asset Number	Area (Sq Ft)	Spaces	Condition	Surface Type	Cost to Improve	Inspection Date	Current Replacement Value
10053584	31297	12	Good	Gravel	\$4,800	03-12-2013	\$158,000

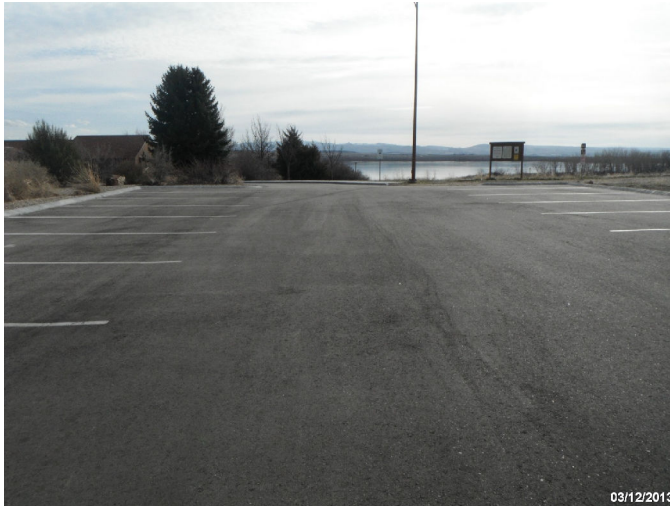
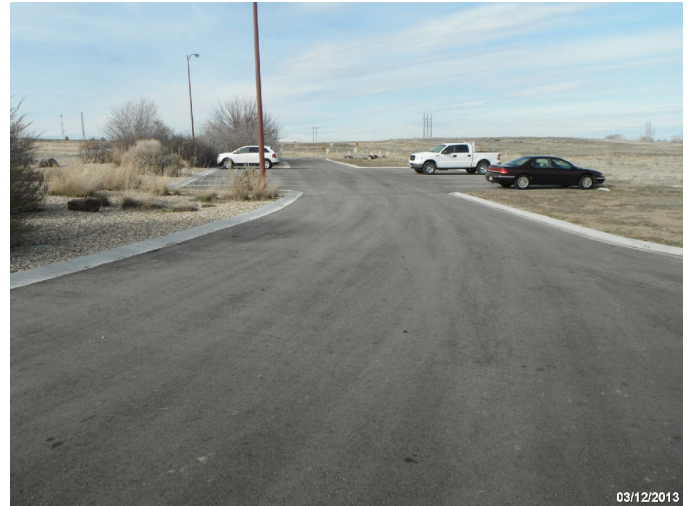
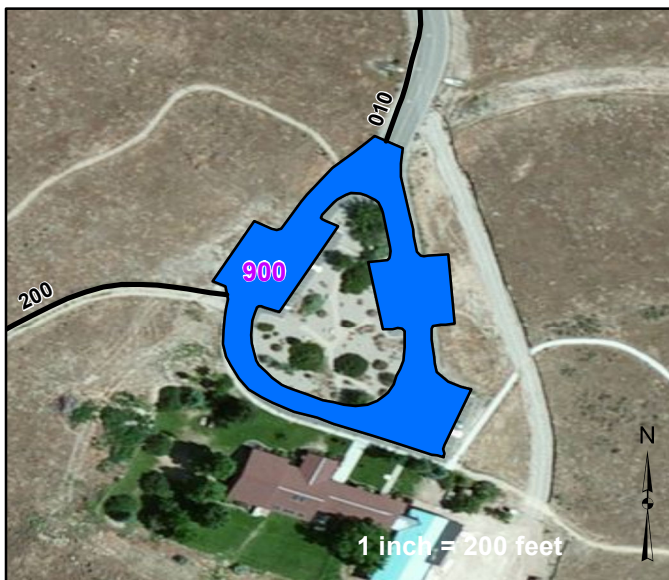
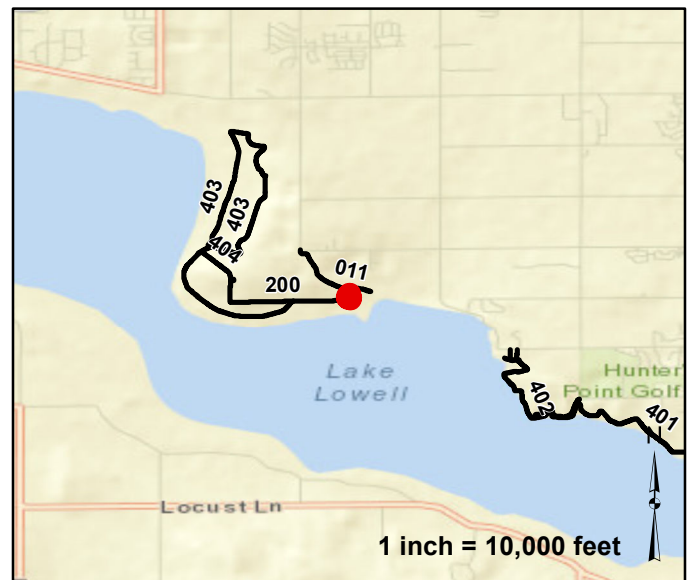
**Route Number: 900**  
**Visitor Center Parking**  
**From Entrance Road (Route 010)**

Asset Number	Area (Sq Ft)	Spaces	Condition	Surface Type	Cost to Improve	Inspection Date	Current Replacement Value
10042373	23774	43	Excellent	Asphalt	\$0	03-12-2013	\$220,000

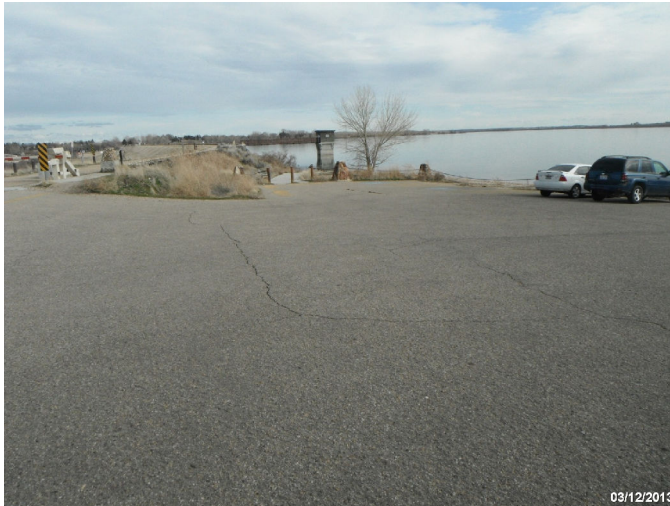
# Route Number: 901

Asset Number	Area (Sq Ft)	Spaces	Condition	Surface Type	Cost to Improve	Inspection Date	Current Replacement Value
10042374	84804	76	Fair	Asphalt	\$74,000	03-12-2013	\$784,600

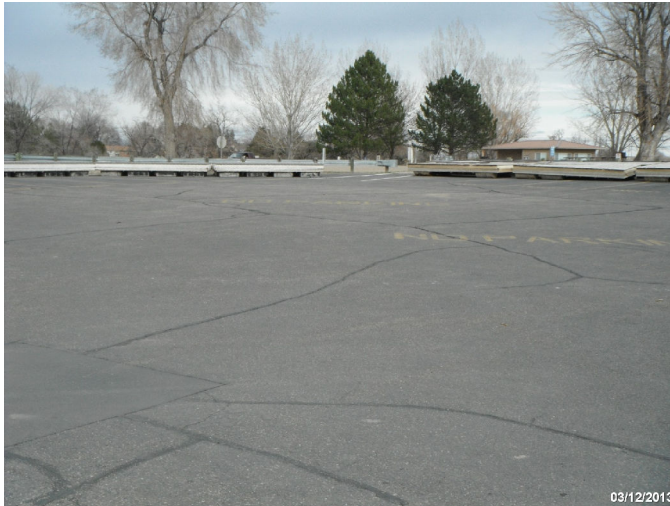
**Route Number: 902**  
**Upper Dam East Parking**  
**From Lake Avenue**

Asset Number	Area (Sq Ft)	Spaces	Condition	Surface Type	Cost to Improve	Inspection Date	Current Replacement Value
10042375	31077	35	Fair	Asphalt	\$27,100	03-12-2013	\$287,500

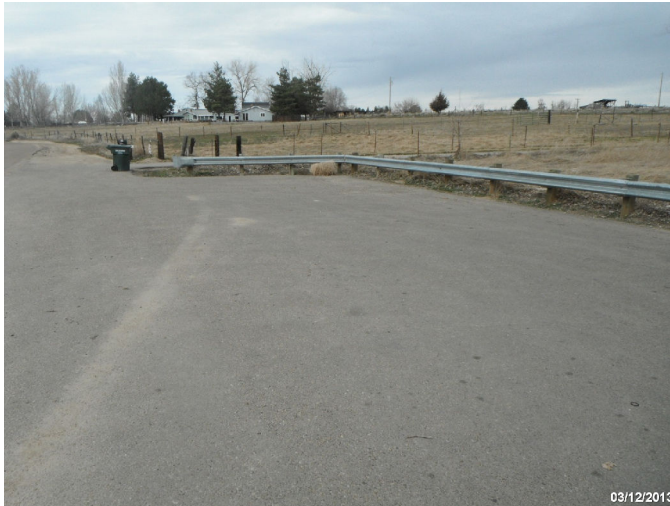
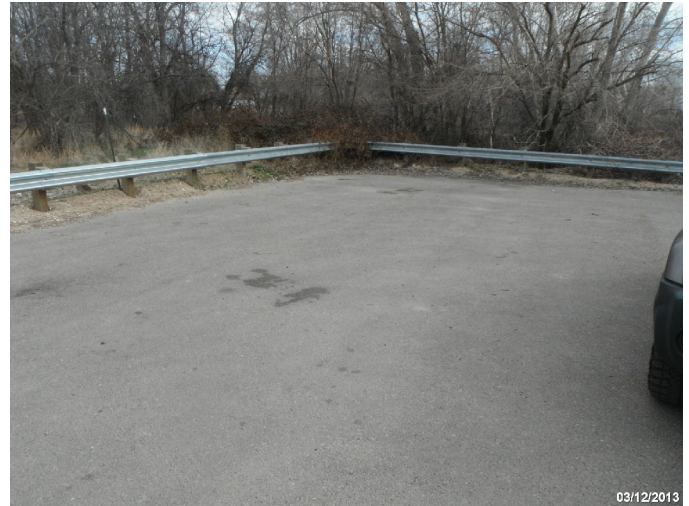
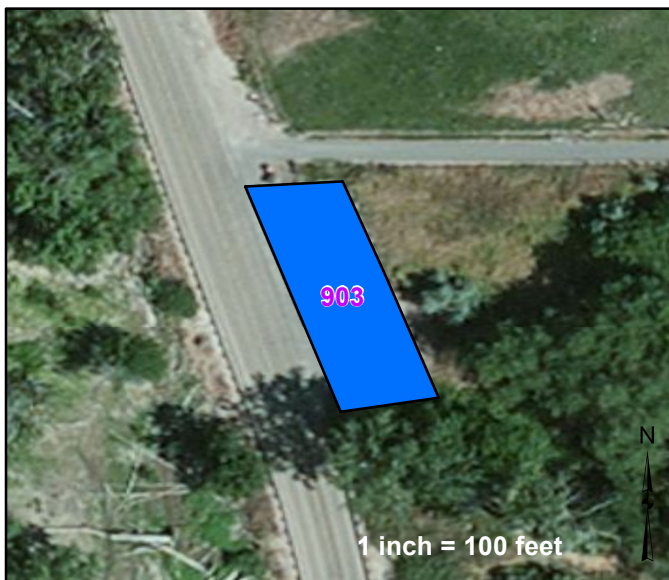
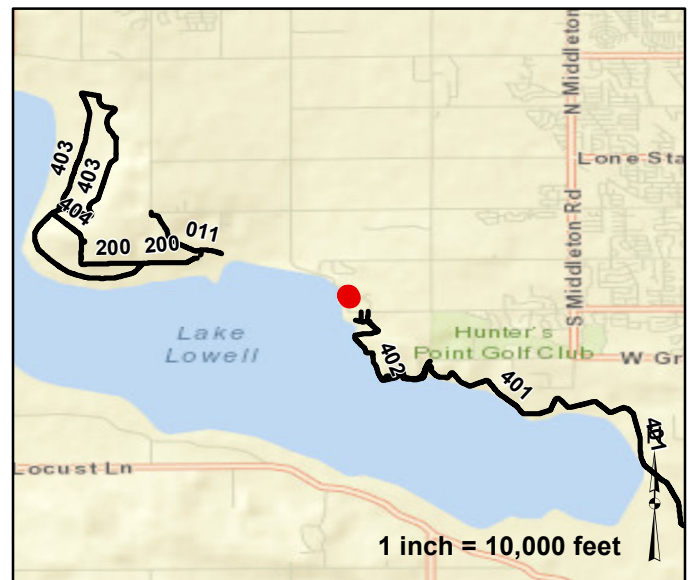
**Route Number: 903**  
**Iowa Ave Parking #1**  
**From Iowa Avenue**

Asset Number	Area (Sq Ft)	Spaces	Condition	Surface Type	Cost to Improve	Inspection Date	Current Replacement Value
10042376	4445	13	Excellent	Asphalt	\$0	03-12-2013	\$41,100

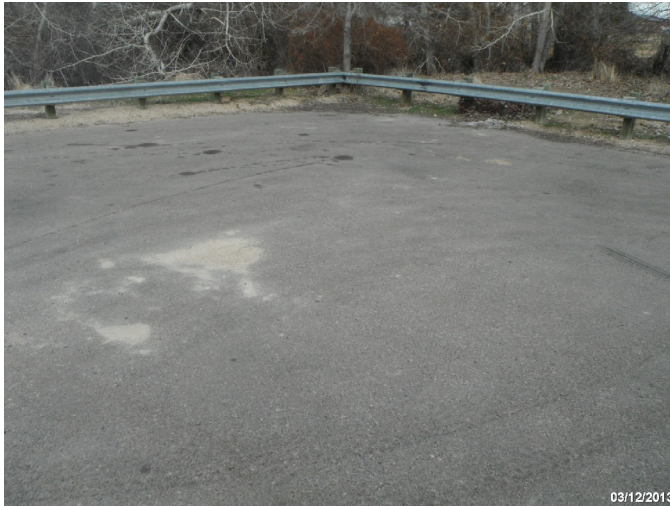
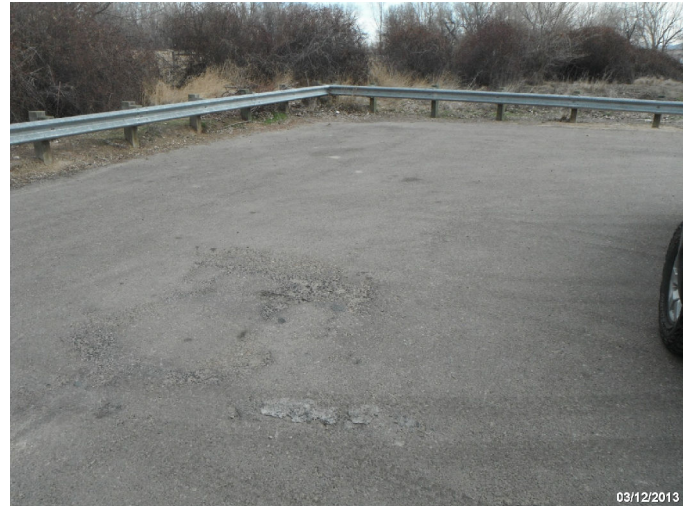
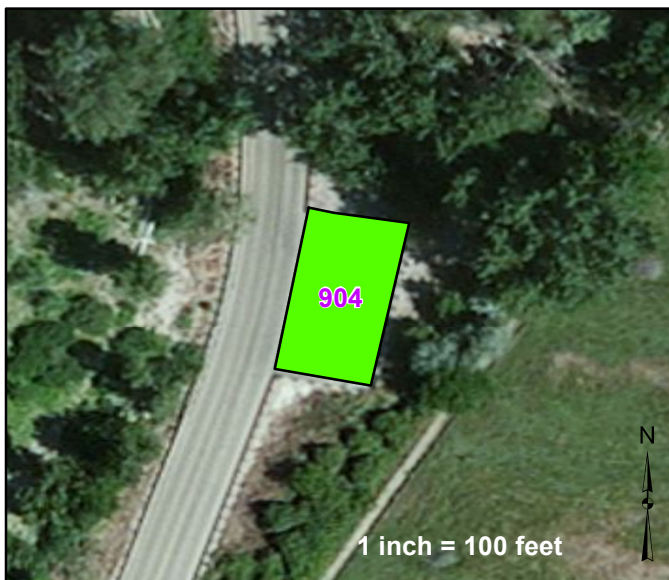
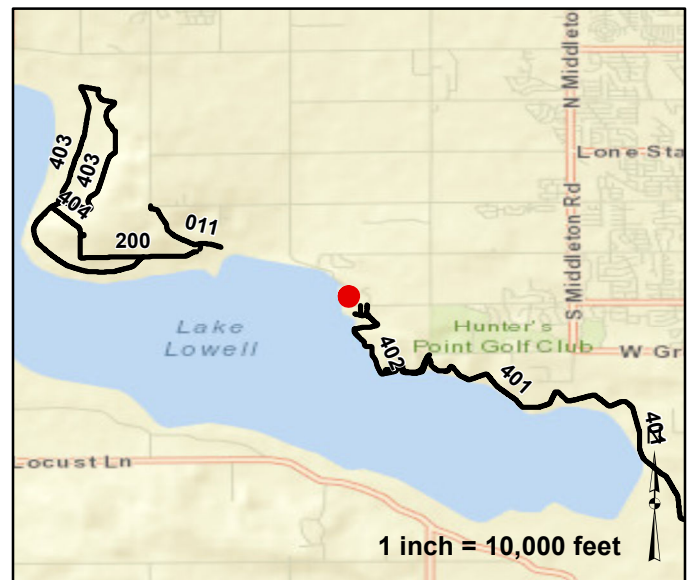
**Route Number: 904**  
**Iowa Ave Parking #2**  
 From Iowa Avenue

Asset Number	Area (Sq Ft)	Spaces	Condition	Surface Type	Cost to Improve	Inspection Date	Current Replacement Value
10042377	3219	9	Good	Asphalt	\$600	03-12-2013	\$29,800
